Tech Tips. #1 / 2004

Tech Tips. #2 / 2004

Tech Tips. #3 / 2004

Tech Tips # 4. September 2005

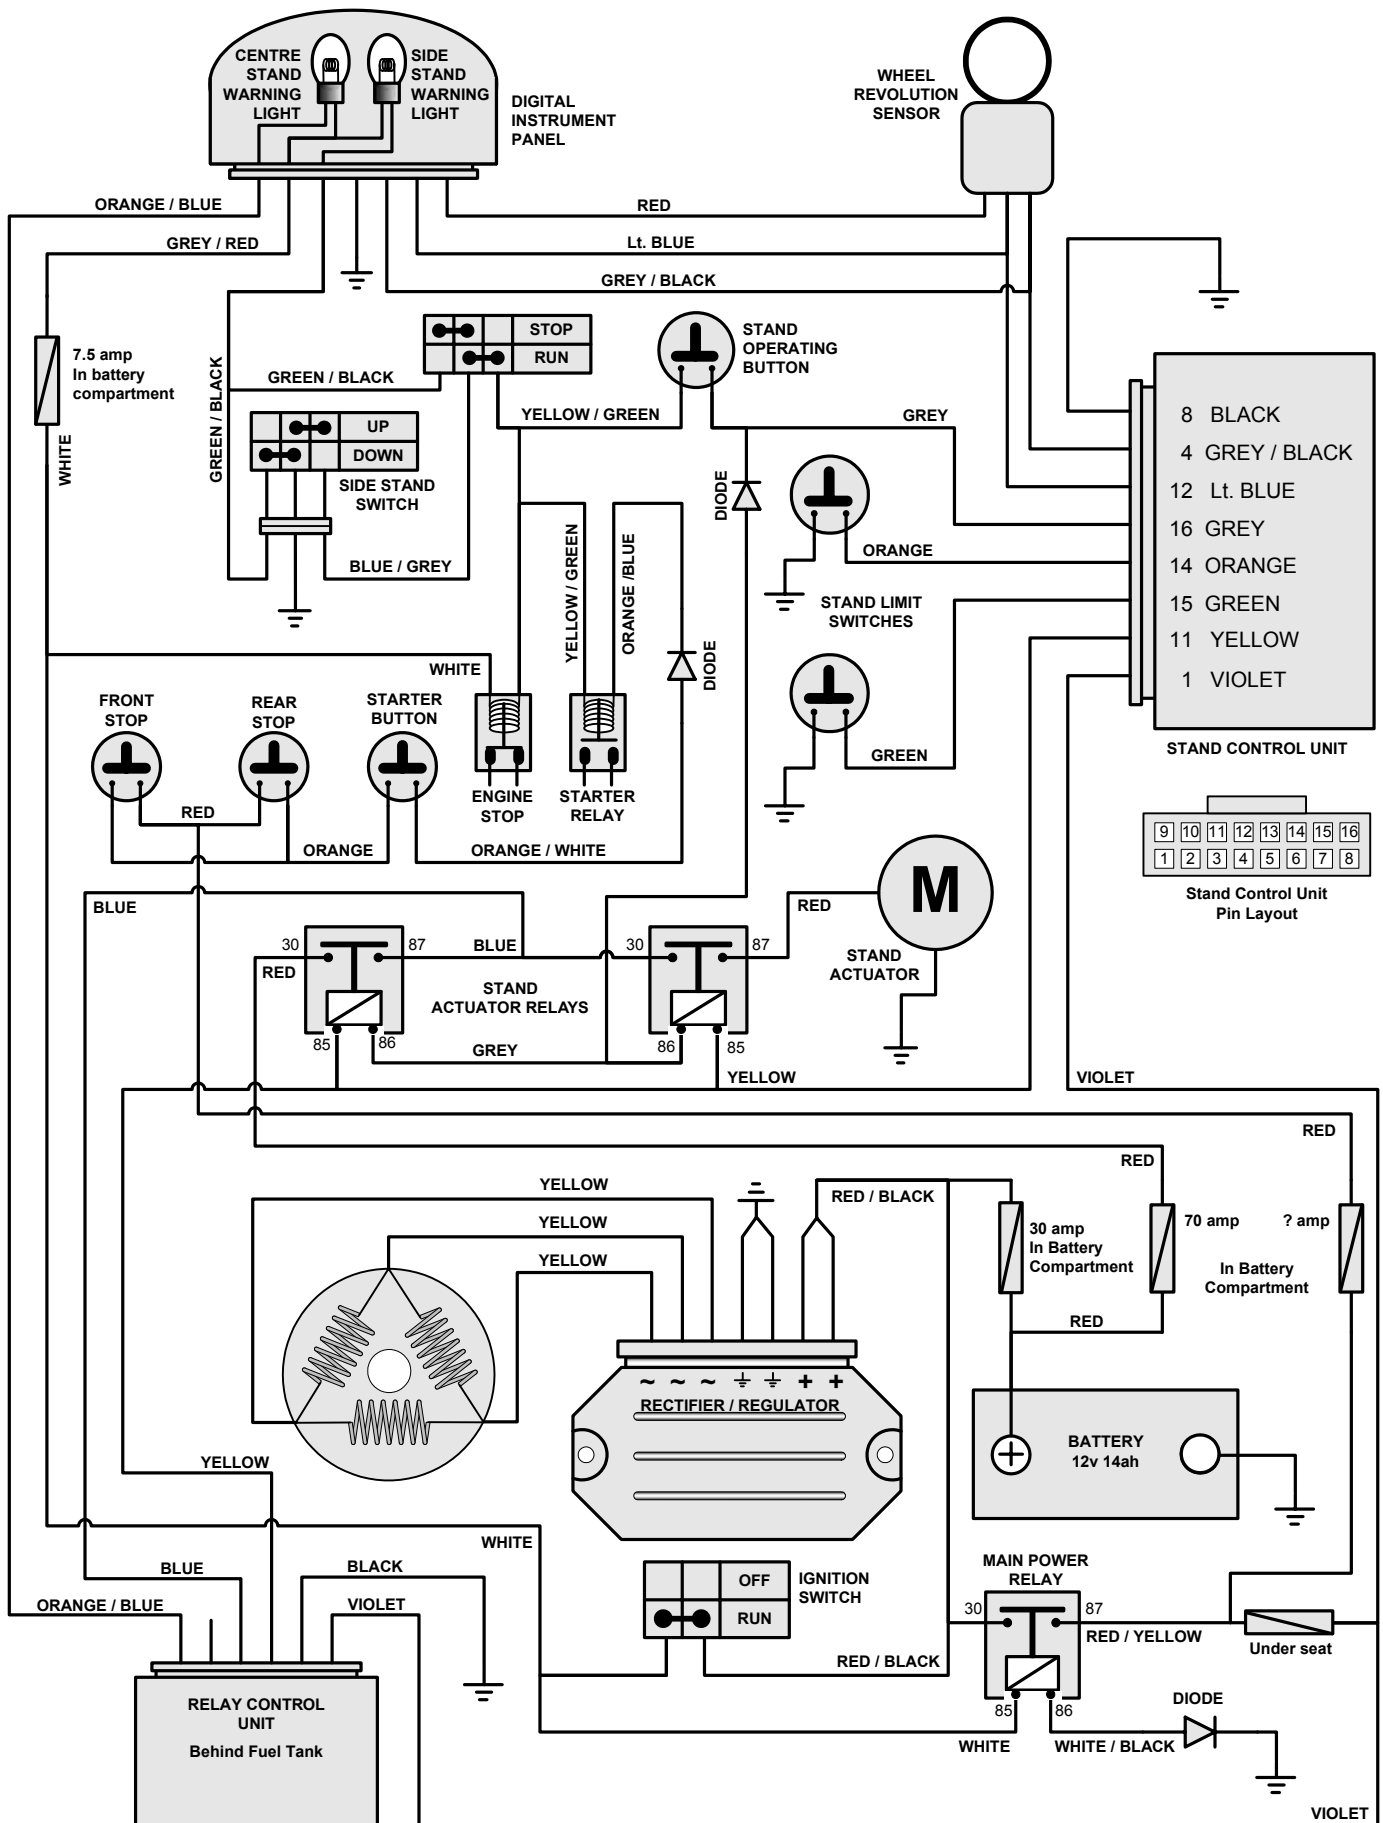
X9 500 Stand Circuit

There are two DIODES situated under the front cover above the headlight unit. They are together in black heat shrink tubing
There is a single DIODE in the grey wire.

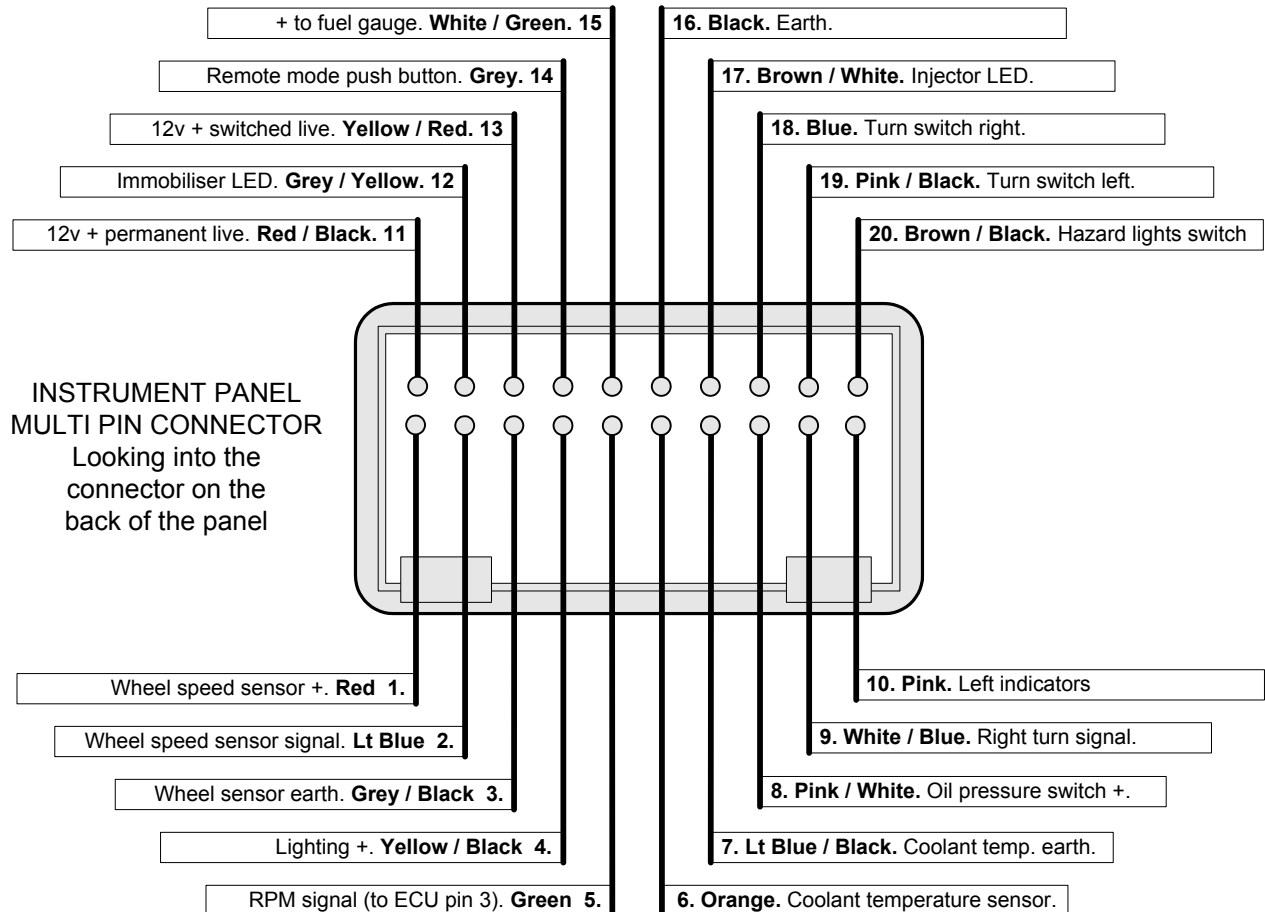
Nexus 500 Instrument connection

You may find an incorrect wiring diagram, with wiring that does not match the vehicle.
This diagram should match the vehicle.

Live feed to switch. Switch shorts to earth to light the bulb.

Live feed to unit in tank. The tank unit shorts it to earth via a variable resistor.
If the gauge is not working.

Low resistance = full tank. High resistance = empty tank.

Un-plug the instruments put a meter between white / green and black.

This has checked the wiring and tank unit.

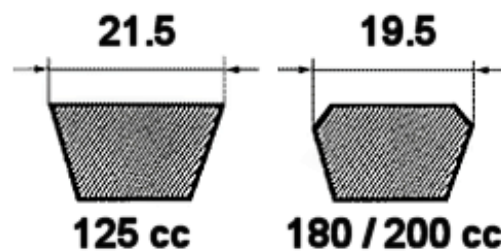
When checking the belt, look for any signs of damage or fraying. Also measure the width at the widest part as explained in the service station manual.

Minimum width for 180 & 200 - 19.5 mm

Minimum width for all 125 ----- 21.5 mm
